INFORMATION BULLETIN

May 8, 2025

EV20 PATROL VEHICLE TECHNOLOGY ISSUES: WHELEN CONTROL HEAD, REPEATER, AND WMVARS

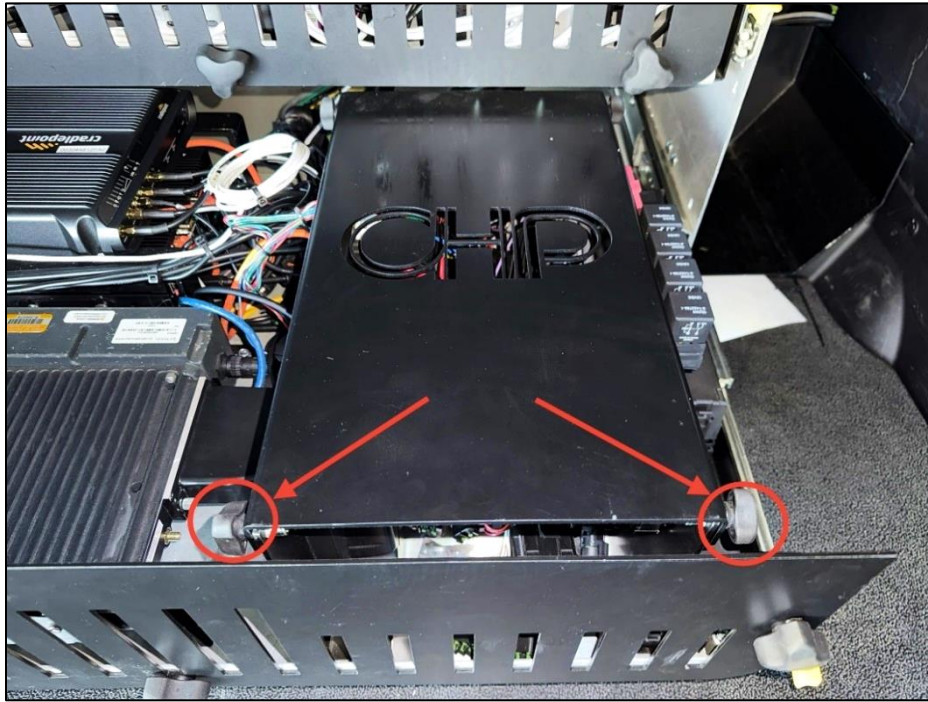
FOS has received reports that some EV20 equipped 2023 Dodge Charger Police Pursuit Sedans have experienced an unexpected shutdown (and restart, in most cases) of the Whelen Control Head and other CHP equipment such as the light bar, mobile digital computer (MDC), WMVARS, etc. CHP FOS has reported these unexpected shutdowns/restarts to Whelen Engineering.

Upon investigation, Whelen Engineering identified a firmware problem which is causing this issue in CHP EV20 2023 Charger vehicles and other Allied Agency vehicles using the Whelen Core control system. Whelen has created new Core firmware to correct the issue and is currently beta testing the firmware to ensure that it functions properly prior to releasing it to their customers.

If the Whelen CenCom Core does not automatically restart, the user will be required to access the rear tray of the patrol vehicle and remove power from the core to restart it. To do this, the user will need to access the lower tray by pressing the yellow tabs along the sides of the tray. Once opened, the user can locate the Whelen CenCom Core by finding the black metal box along the right side of the tray, covered by a black metal plate bearing a CHP logo. The user will then need to open the black metal cover by removing the two (2) thumb screws closest to the user (see photo).

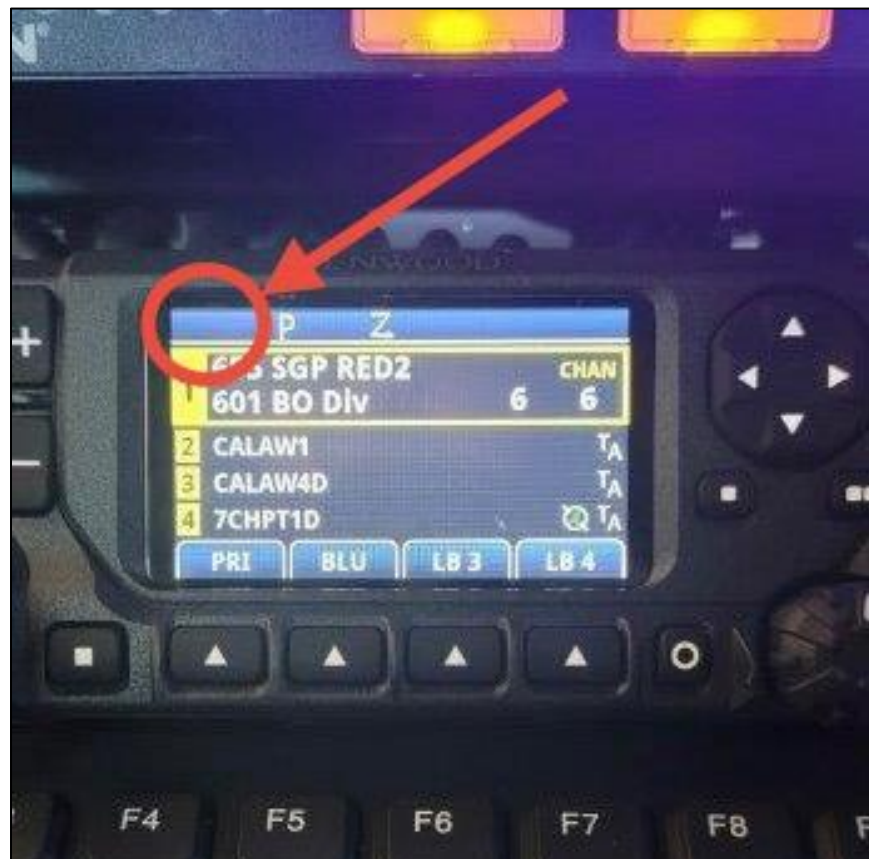
The TS is aware of an issue causing the repeater to malfunction and become unusable. In short, there is a component (the multi-deck interface [MDI]) which provides instructions to the multiple radios regarding how to interface with the radio head and what repeater channel to associate with the low-band frequencies (colors). During this repeater error, the user is unable to transmit or receive radio traffic using their portable radio. The mobile radio will still function. If the top left corner of the mobile radio LCD screen is blank, there is an error with the communication between the mobile radio and the MDI. When working properly, the Vehicle Repeater System (VRS) link channel will be displayed in the top left corner of the LCD screen.

To resolve this issue, the user should shut down and reboot their patrol vehicle. To do this, exit all MDC applications and perform a Windows shutdown. Then power off the patrol vehicle and press the “Load Management” button on the Whelen Light Bar Controller. Once all the equipment has powered down, restart the patrol vehicle, activate the repeater, and perform a radio test with dispatch.

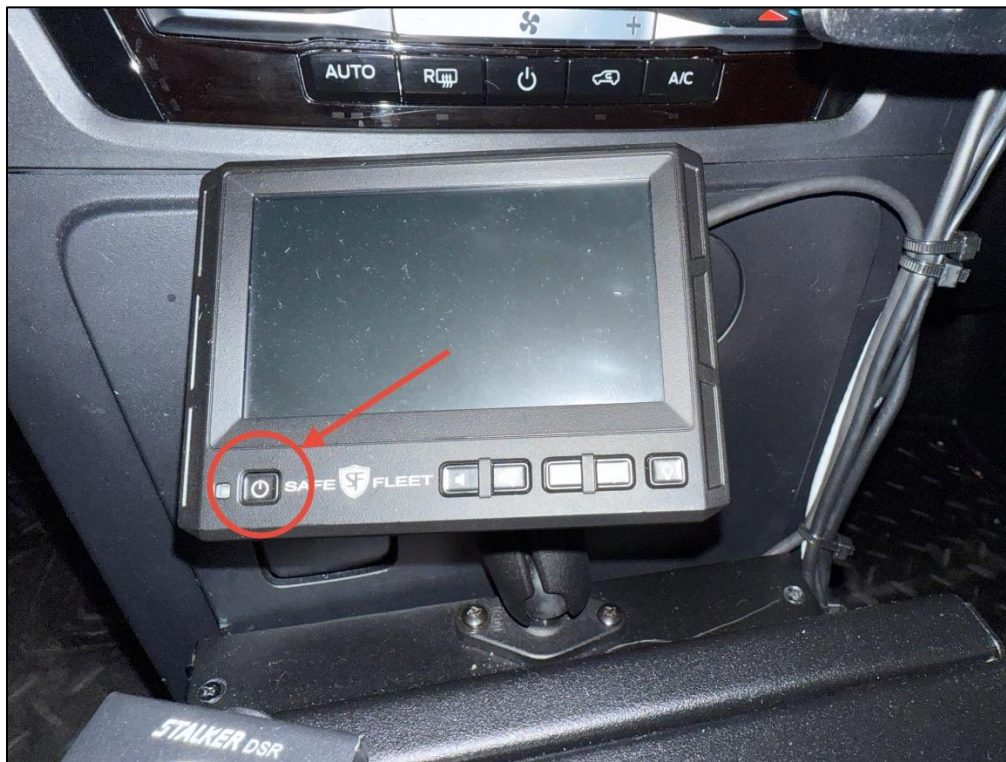
The TS and FOS are aware of an issue causing the WMVARS main unit to shut down unexpectedly. It was determined this issue was caused by excessive heat buildup in the trunk area of the EV20 patrol vehicle. This issue primarily effects Dodge Charger Police Pursuit Sedans.

Presently, the only resolution to this issue is to mitigate the heat within the trunk area of the patrol vehicle. It is recommended the user return to their respective Area office, park in a shaded area, open the trunk lid of the patrol vehicle, and allow the heat to dissipate. When the temperature of the trunk and WMVARS main unit drops below 158 degrees, the user will need to manually power on the WMVARS system by pressing the power button on the small WMVARS screen (see photo).

If the above solution is unsuccessful, allow the trunk area to cool longer and repeat the final step. Additionally, upon restart of the WMVARS system, body worn cameras (BWC) and microphones should be resynced as a precaution.
